## **Long-term performance of distributed optical fiber sensors embedded in reinforced concrete beams under sustained deflection and cyclic loading**

# Long-Term Performance of Distributed Optical Fiber Sensors Embedded in Reinforced Concrete Beams under Sustained Deflection and Cyclic Loading

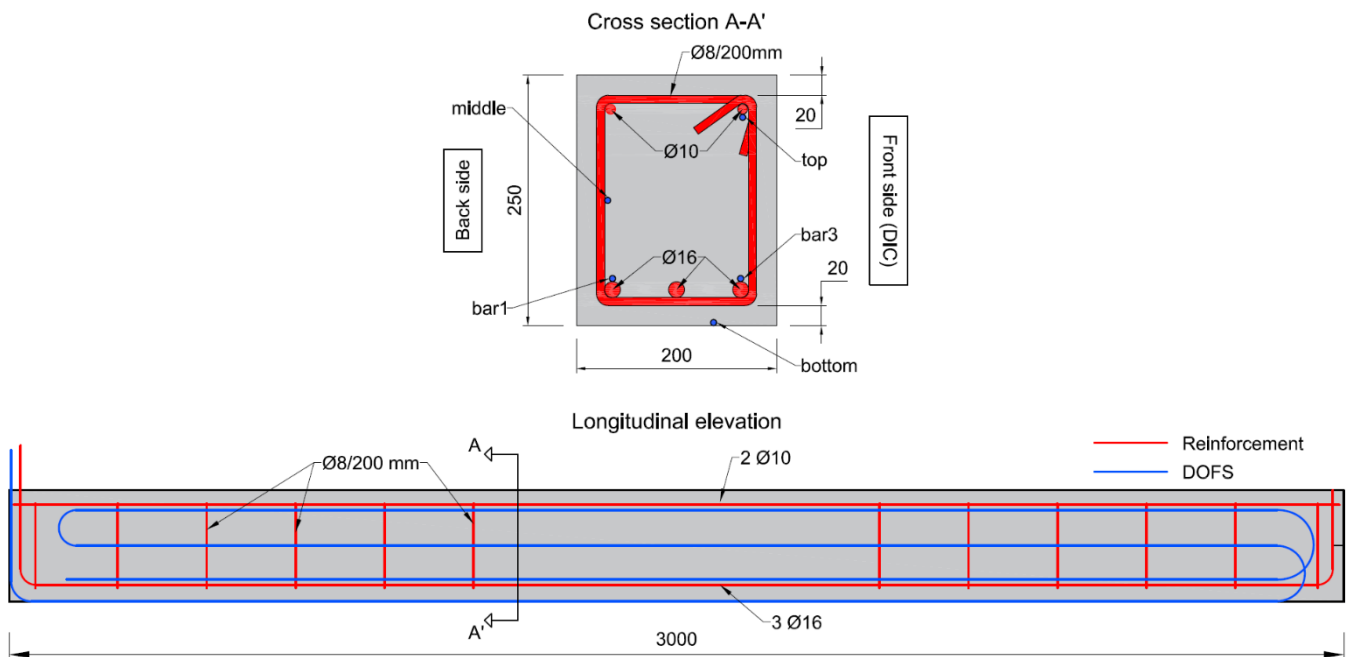
**Figure 1.** Geometry of the beam specimens, reinforcement layout and DOFS configuration (all measurements in mm).

The specimens used in this work were RC beams with a total length of 3 m and a rectangular cross-section of  $200 \times 250$  mm. Each beam was reinforced with three  $\varnothing 16$  mm rebar at the bottom and two  $\varnothing 10$  mm at the top. Moreover, six  $\varnothing 8$  mm closed-loop stirrups equally spaced at 200 mm were placed on either side of the beams. All reinforcement was made of normal ductility carbon-steel (B500B) with a nominal yield strength of 500 MPa. Plastic spacers were placed between the stirrups and the bottom and lateral sides of the form to ensure a clear concrete cover of 20 mm. The ends of the bottom bars were bent upwards to improve the anchorage. The geometry and reinforcement layout of the beams is presented in Figure 1. Note that at one of the beam ends, the bars protruded from the concrete surface, which was required for a later stage of the experiments in which accelerated corrosion was planned.

For each beam, a single DOFS was installed in a multilayer configuration to monitor the variation of strain along the beam in the region between the supports at five different locations of the beam's cross-section: above the two outer tensile rebars (bar 1 and bar 3); under one of the compressive rebars (top); at mid-height (middle); and at the bottom surface of the beam (bottom). The DOFS were either supported along the longitudinal reinforcement (bar1, bar3 and top), fixed to the stirrups (middle) or resting on the formwork (bottom), using electric tape to fix the sensors in place.

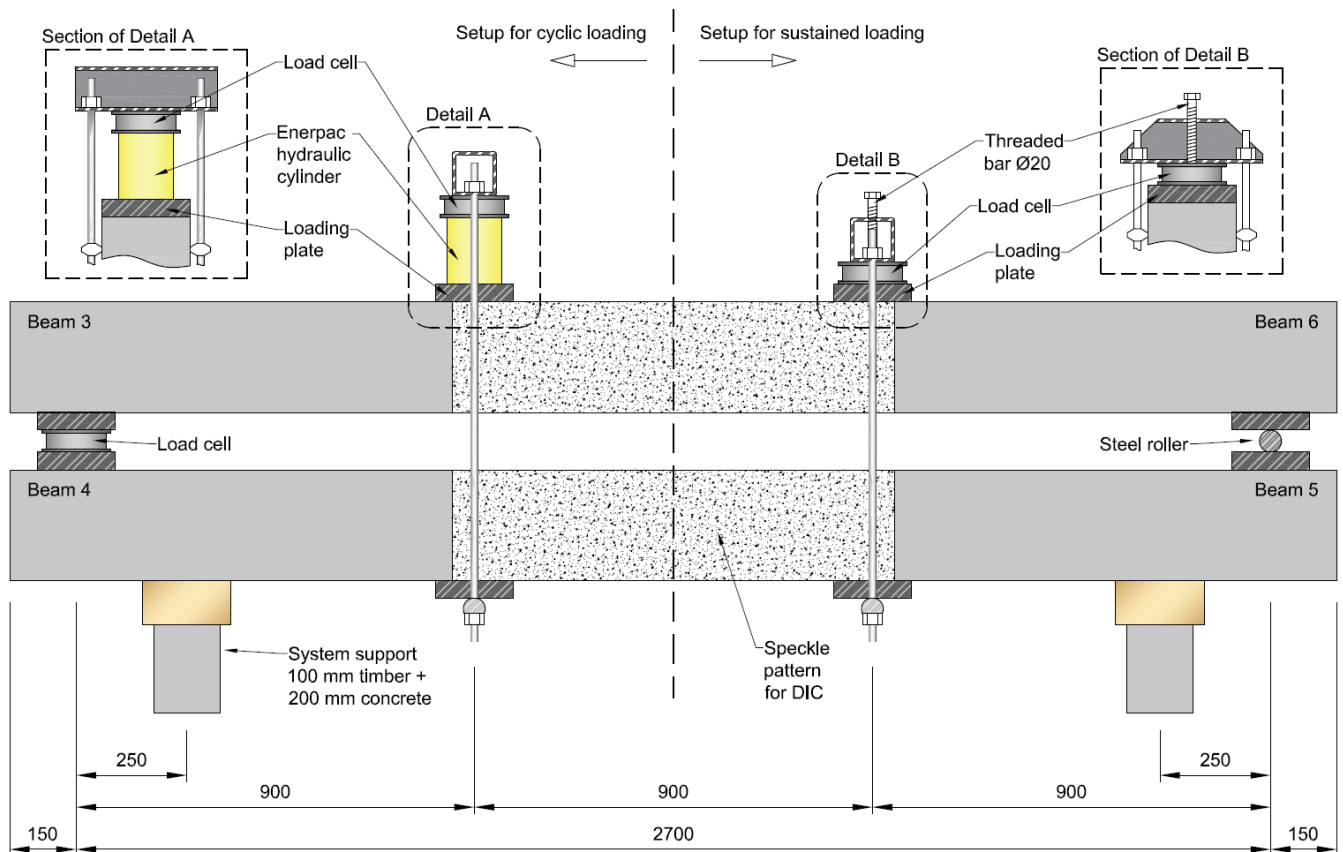
**Figure 2.** Loading setup for the long-term loading experiments (all measurements in mm).

For the long-term loading, the beams were divided into two groups and the beams in each group were clamped together according to the setup illustrated in Figure 2. In that setup, the bottom beam was turned upside down so that the tension reinforcement was facing upwards. Then, the top beam was positioned onto two sets of support plates resting on the bottom beam, the centers of which were 2700 mm apart. Thereafter, the load was introduced at two loading points, where the clamping devices were mounted, which divided the total span into three equal spans of 900 mm.

For the group of beams subjected to cyclic loading, a hydraulic cylinder was placed between the clamping device and the loading plate of the top beam, cf. Detail A in Figure 2; the imposed deformation on the group of beams subjected to sustained deflection was achieved by tightening a threaded bolt screwed into the clamping device, cf. Detail B in Figure 2. Two load cells were provisioned at the loading points over the top beam and one more between the support plates at one of the ends in order to ensure a symmetric load distribution. The load of the Enerpac hydraulic cylinder was automatically controlled using a close-loop feedback control system retrofitted with the measurement of the load-cells.

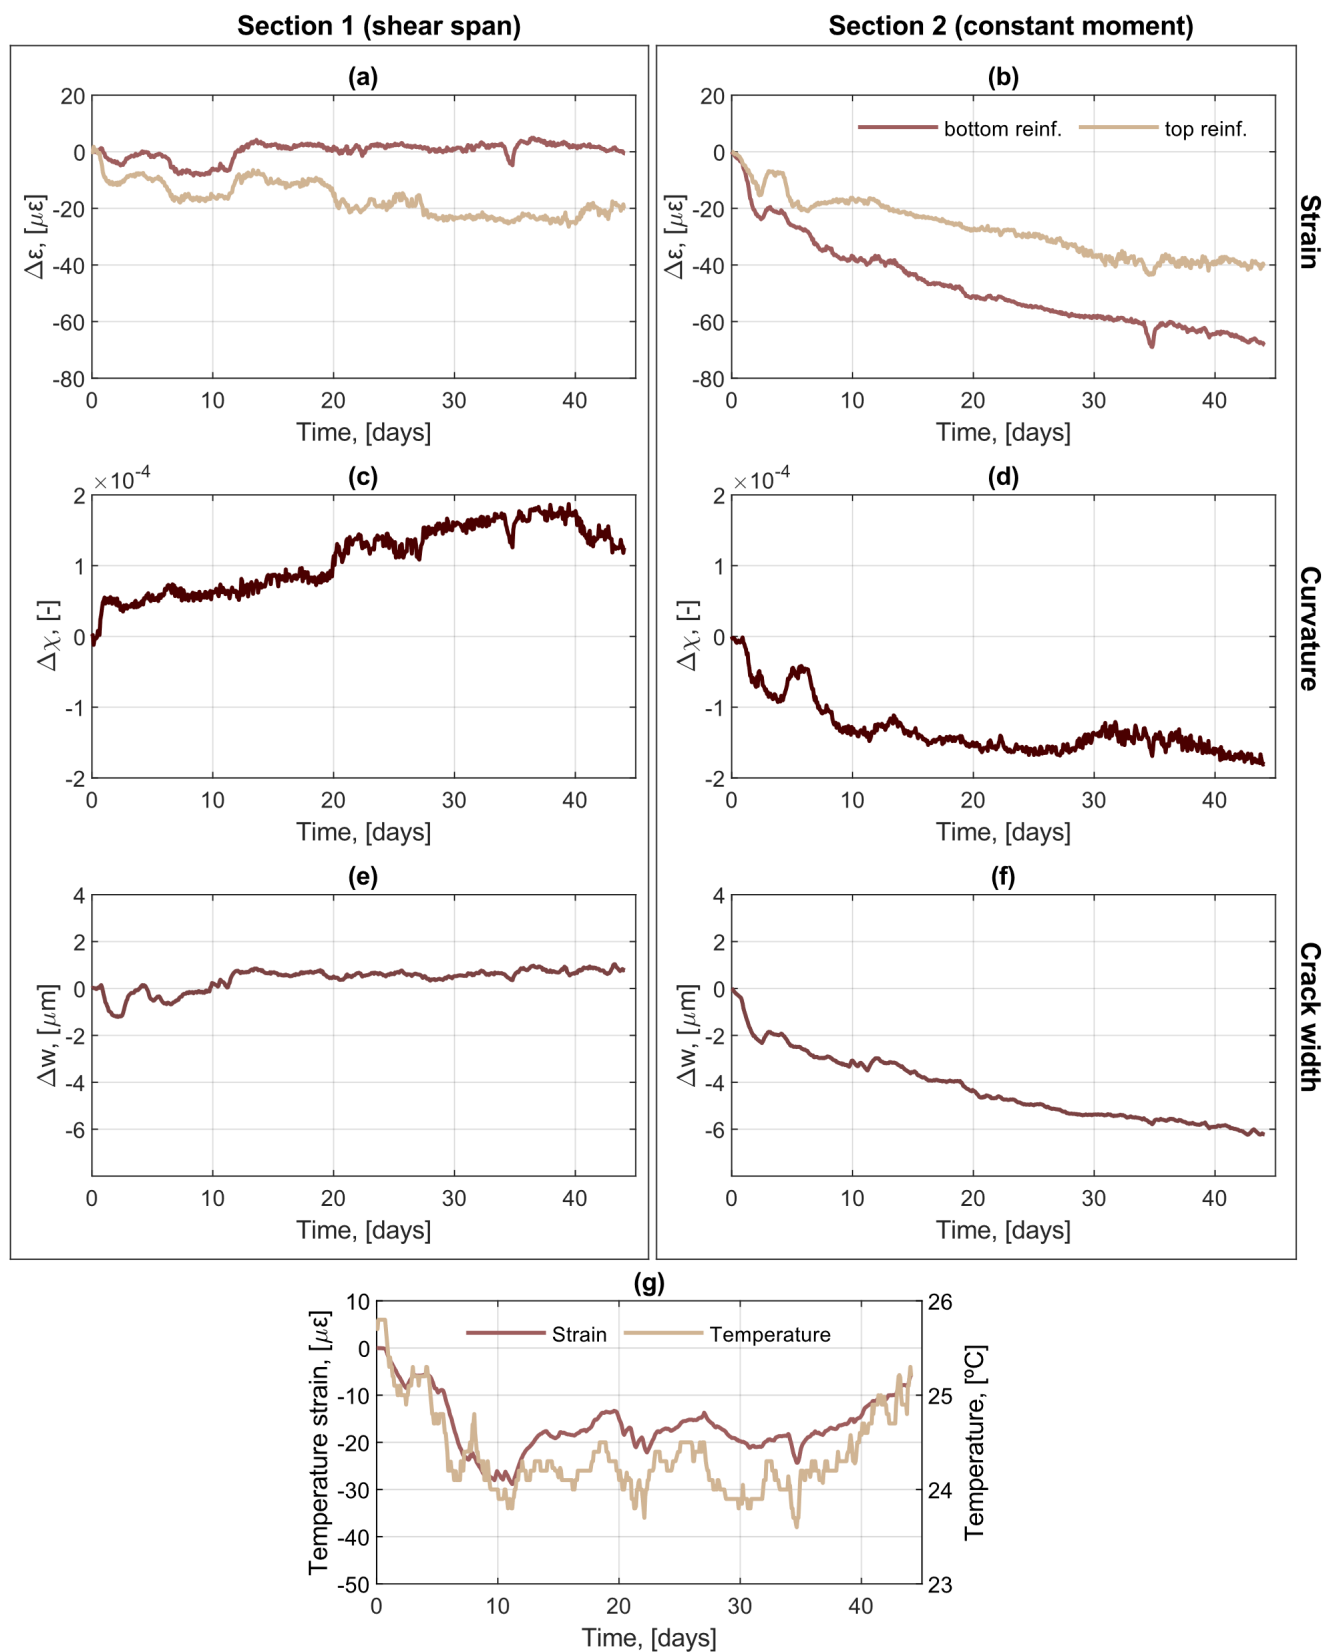
**Figure 5.** Incremental variation of measured and calculated magnitudes in the beam over time for Sections 1 and 2: (a,b) strain; (c,d) curvature; (e,f) crack width. (g) Variation of ambient temperature and the corresponding temperature-induced strain.

The increments of strain at the top and bottom reinforcement, the increments of curvature and the increments of crack width during period 1 is presented for Sections 1 and 2 in Figure 5a,c,e and Figure 5b,d,f), respectively. Furthermore, Figure 5g shows the measured ambient temperature and the variation of strain in the concrete attributable to temperature changes. The temperature strain, which is used for temperature compensation, was obtained by analyzing the strain in a section of the fiber optic cable embedded beyond the beam support, hence in a section without mechanically induced strains.

Looking at the results of Section 2, Figure 5b reveals that the strains at the bottom reinforcement suffer a negative increment, i.e., they decrease in magnitude, which can be explained by the progressive loss of load observed, although to a lesser extent, the strains at the top reinforcement also become more negative, i.e., they increase in magnitude, which can be attributed to the concrete creep in the compressive zone of the beam. Note that the increase in magnitude of the compressive strains is not incompatible with the decrease in load since creep-induced strains are not mechanical strains. However, they do contribute to the curvature and deflection of the beam. Accordingly, using the strain at the bottom

Interestingly, the curvature at Section 1, located in the shear span of the beam, follows an opposite trend to that of the curvature at Section 2. In Section 1, the strain at the top reinforcement decreases similar to what was observed for Section 2, which can also be attributed to the effect of concrete creep. Conversely, the strain at the bottom reinforcement does not display any significant change. This seems to indicate that a redistribution of curvature in the beam occurs under conditions of sustained deflection, where the curvature decreases in the most loaded region, where the curvature is initially larger, and it increases in regions where the curvature is lower from the start.

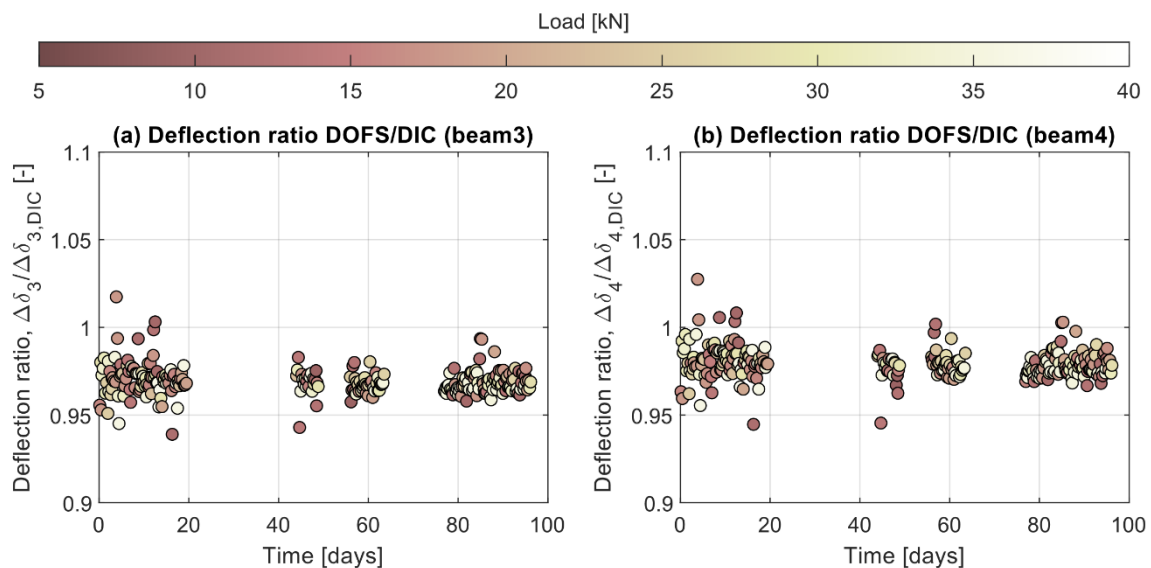
**Figure 11.** Ratio of the deflection increment calculated from the DOFS and measured by the DIC for (a) beam 3 and (b) beam 4.

positive for beam 3 and negative for beam 4. The comparison of the deflection increments for each individual cycle is presented in Figure 11a,b in the form of deflection ratios between the DOFS and the DIC for beam 3 and beam 4, respectively. As observed, in both cases the mean error is below 5%, which agrees with previous results by the authors [25]. Furthermore, it is worth highlighting that the results show very little scatter and that no apparent influence of the applied load level nor the number of cycles can be observed. These results reveal that the calculation of deflections based on DOFS is reliable over time, even under repeated load cycles, and potentially more robust than non-contact image-based systems since it does not require a fixed external reference for the computation of deflections.

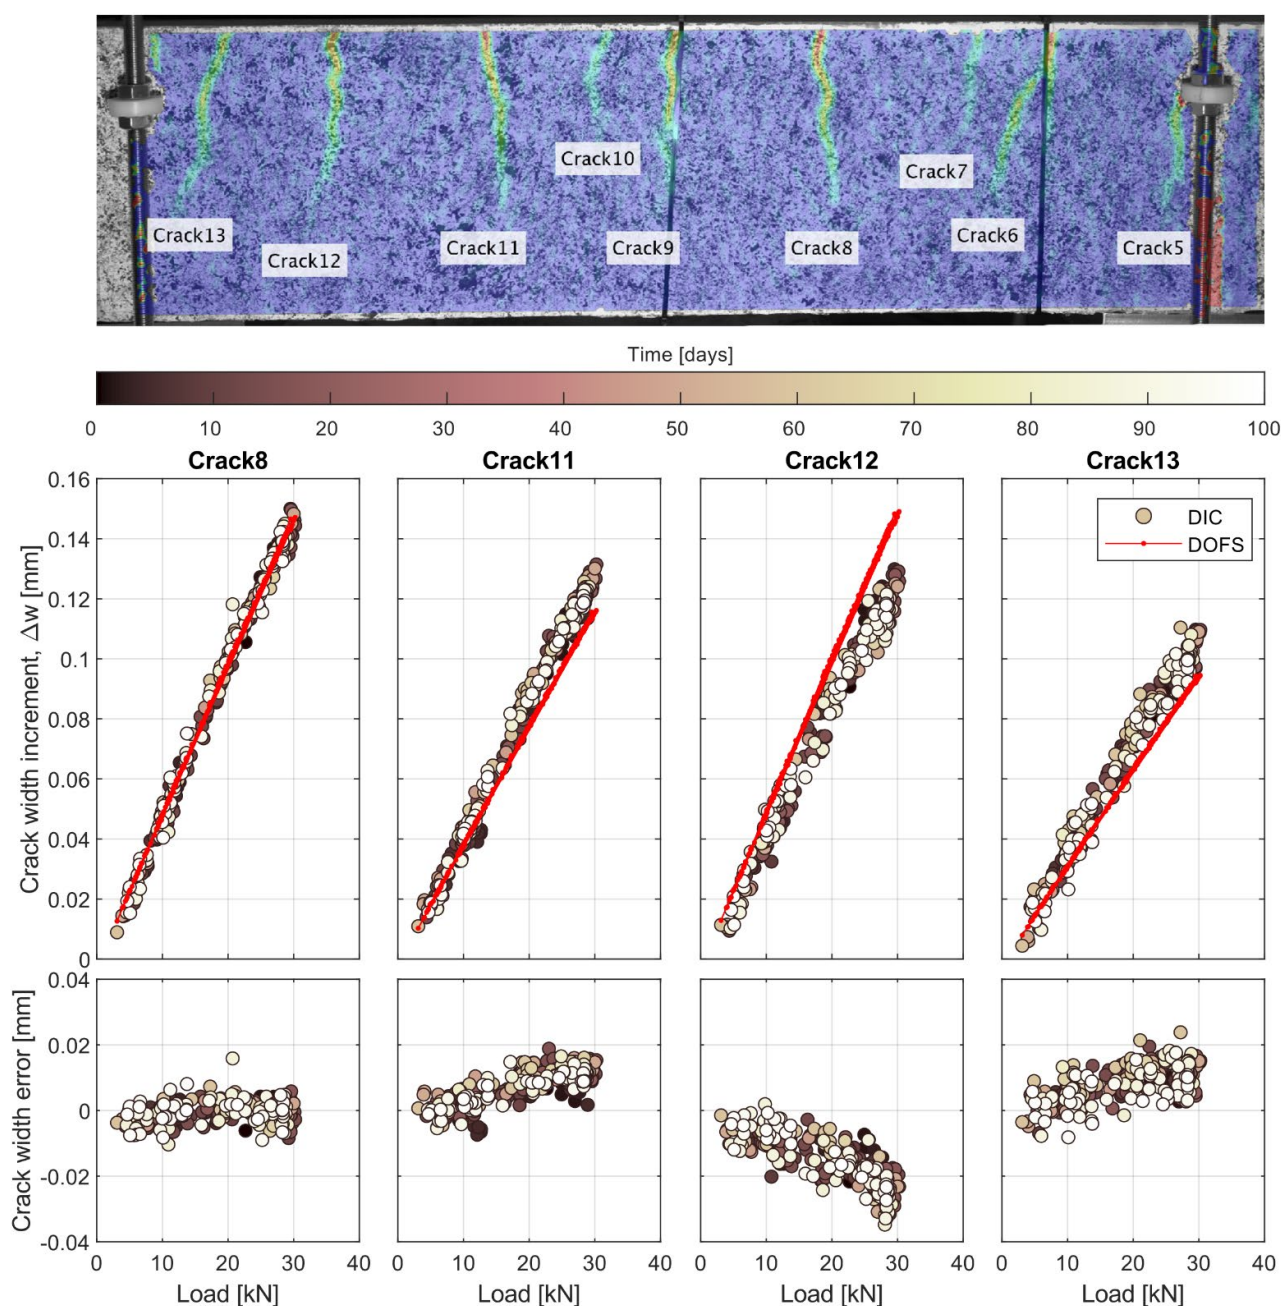
**Figure 12.** Results of the DIC showing the field of principal strains to highlight the position of cracks on the surface of beam 4 along the region of constant bending moment (**top**). Relationship between increment of crack width and applied load for selected cracks (**middle**). Crack width error between the DIC and DOFS measurements (**bottom**).

The results of the comparison are presented in Figure 12 as a function of the cycle load, where each marker corresponds to one cycle and the color of the marker indicates the time, in days, for which the cycle occurred. Additionally, the crack width error calculated as the difference between the increment of crack width measured by the DIC and the DOFS is also presented in Figure 12 for each crack. In terms of accuracy, it can be observed that the agreement between the DOFS and the DIC varies from crack to crack but, overall, the maximum error is generally below 0.02 mm, except for one crack where it reaches 0.04 mm at higher loads, which is in accordance with previous results [25]. Moreover, in all

cases the relationship between the increment of crack width and the applied load remains linear for both the DIC and the DOFS. This agrees with the results shown in Figure 9b,d, in which despite a certain variation of the total crack width over time, the variation of crack width between the peak and low cycle loads remained nearly constant. The fact that increment of crack width stayed proportional to the applied load over time suggests that the cyclic loading did not cause any significant bond degradation, which otherwise would be translated into an increased crack width over time. Furthermore, it is worth noting that despite the linearity observed in the results from both systems, the DOFS results exhibit a much lower scatter than the DIC. These results further highlight the potential of DOFS for monitoring of RC structures.
